The Temperature Pressure Relief Valve

The most important part of your client's domestic hot water system

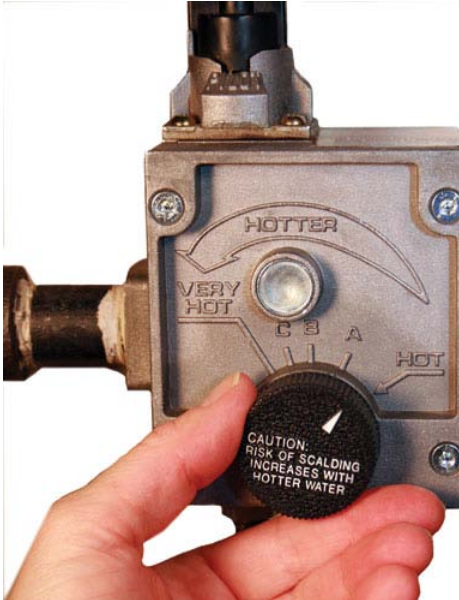
Photo: Electric thermostat with high limit. Photo © Camco Manufacturing, Inc.

Water heaters have thermostatically controlled devices that keep them from overheating. Both gas and electric water heaters have temperature-limiting devices that shut off the energy source when their regular thermostat fails. Electric heaters have a high-limit switch that interrupts the power when overheating occurs. Many of us have seen and perhaps reset the device by pushing a small red button under the cover plate and just above the thermostat dial.

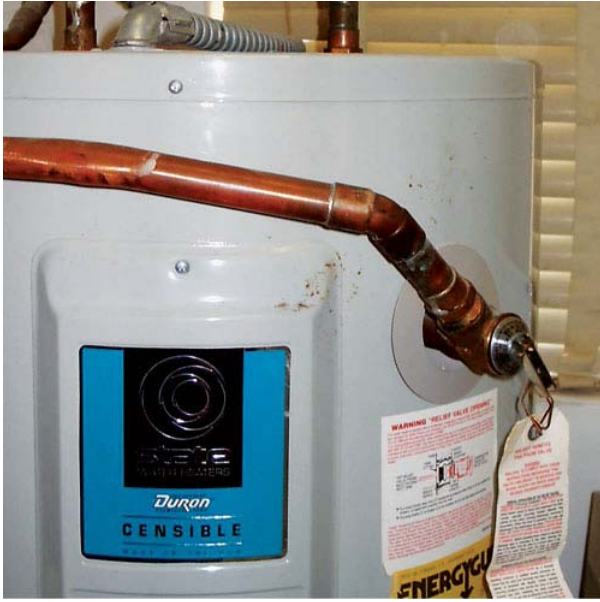
Photo: Watts® L100XL is their model TPR valve for heavily insulated tanks. Photo © Watts®.

On water heaters with very thick insulation, you'll sometimes encounter an issue with the TPR valve that is related to the insulation itself. Because of the depth of the insulation, the threaded opening is somewhat recessed within the jacket placed around the tank. Installers sometimes add a nipple and a coupling to the end of the TPR valve to bring it out beyond the insulation and jacket. This can cause the thermostat on standard-length TPR valves to line up inside the nipple, where it's unable to truly sense the water temperature. Special TPR valves with an extended shank should be used for this application. It not only gets the valve out beyond the insulation, but it is designed with an extended thermostat that keeps it well inside the tank surrounded by water. The extended shank is part of the valve itself, and no nipple is needed.

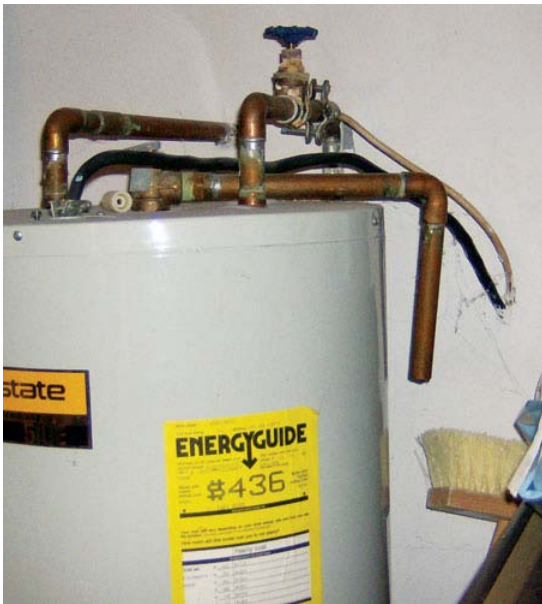
Photo: Trapped TPR valve. Photo by K. Hart.

In recent years, many water heater manufacturers have relocated TPR valve openings. They have moved them from the top to the side of the tank. When older heaters are replaced with similar height units, installers occasionally will turn the valve so it can be realigned with the original discharge pipe that extends from the wall. This often results in the trapping of the valve, preventing it from draining by gravity. If the valve drips, mineral deposits can collect at the opening and create a mineral plug. This can restrict or block the opening altogether. Neither the TPR valve nor the discharge piping should ever be trapped and should always drain completely by gravity.

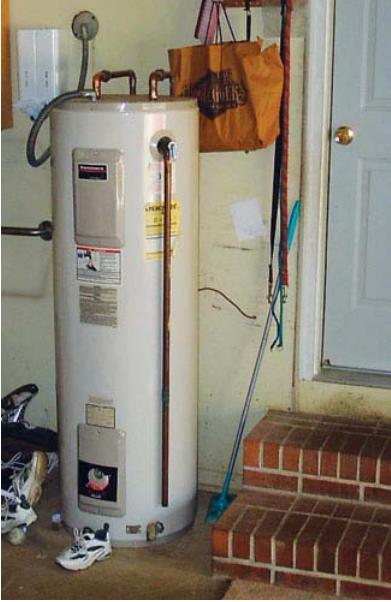
Photo: Water heater installed in a garage. Photo K Hart.

When a water heater is installed in a garage, attached storage room or similar location, simply extending the discharge pipe toward the floor is a common practice. So long as any discharged water will not cause structural damage, this is generally the preferred method of directing it to a safe location. The pipe should not terminate more than 6 inches above the floor because of splash concerns or closer than two pipe diameters to the floor, a potential cross-connection issue. A pipe too close to the floor could end up submerged and could siphon dirty water into the tank.

A common mistake with water heaters resting on raised platforms in garages is to stop the discharge pipe just above the platform instead of the floor. Should the valve discharge here, the spray or splash of the scalding hot water at this level could seriously injure anyone standing nearby. The pipe should be offset around the platform base and stopped above the floor.

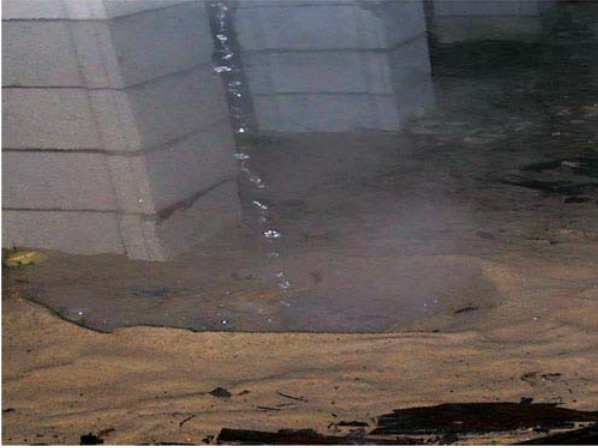
My own personal experience underscores why the discharge pipe should never stop in the crawl space, an area certainly not routinely readily observable by your average occupants of the house. Once, during a property inspection, I noticed extensive mold-related, structural damage as I entered the crawl space of an apartment building. This was a surprise since the property was located at the beach, was built over sand and was high enough for me to walk under. As soon as I entered the area, I heard a large blast of water begin slapping the ground. I turned and realized that the TPR valve had been discontinued in the crawl space and was releasing at that very moment. I snapped a picture (*see photo below*). Within two or three minutes, a cloud of steam filled the entire crawl area.

Photo: Discharging TPR valve in a crawl space. Photo by K. Hart.

After questioning the tenants, it seemed this periodic release of superheated water had been going on for quite some time and though they could hear the water flowing through the plumbing, no one associated it with the water heater. There was more than \$30,000 in structural damage to that steam-soaked crawl space. It could have been avoided if the discharge pipe had been extended to the outside.

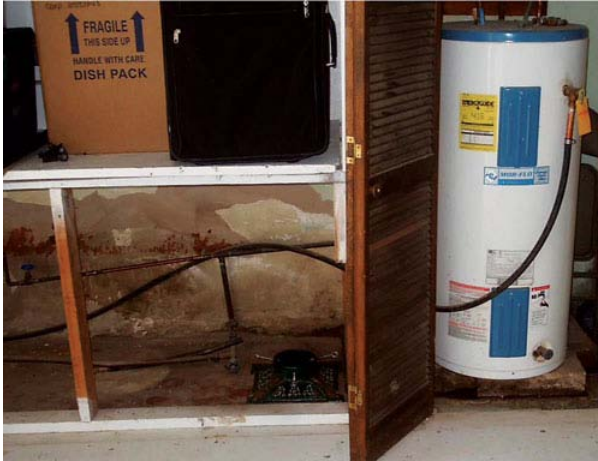
Photo: Constructed of old garden hose, a non-approved piping material, the discharge pipe on this garage located water heater was simply replaced with a run-off tube that terminated a couple of inches above the floor. Photo left K. Hart.

It's human nature to want to stop a water leak. Because of this, discharge piping should not terminate with a threaded connection as it provides an easy means of capping the line, making the valve unable to discharge. In my experience, threaded outlets tend to be more common with the D-I-Y installer since pre-cut threaded sections of steel pipe can be purchased from the local hardware or big box store, then simply screwed into the valve's outlet. If the valve drips or water is found at the floor, a trip to the junk drawer often produces a $\frac{3}{4}$ -inch cap to hold back the water until the plumber arrives. When a cap is not located, it's sometimes realized that, with a little coaxing, a garden hose can be connected to direct the water outside. Scalding water and garden hoses do not mix. If the hose collapses, the result is a 25-foot-long plug attached to the pipe.
